SOUTHERN HILLS PLANTATION I COMMUNITY DEVELOPMENT DISTRICT April 8, 2024 **BOARD OF SUPERVISORS REGULAR MEETING** AGENDA

Southern Hills Plantation I CDD Aquatics

Inspection Date:

3/29/2024 9:45 AM

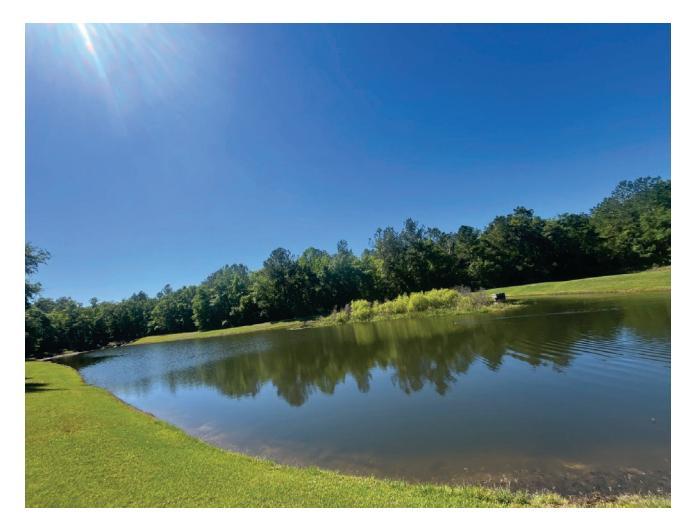
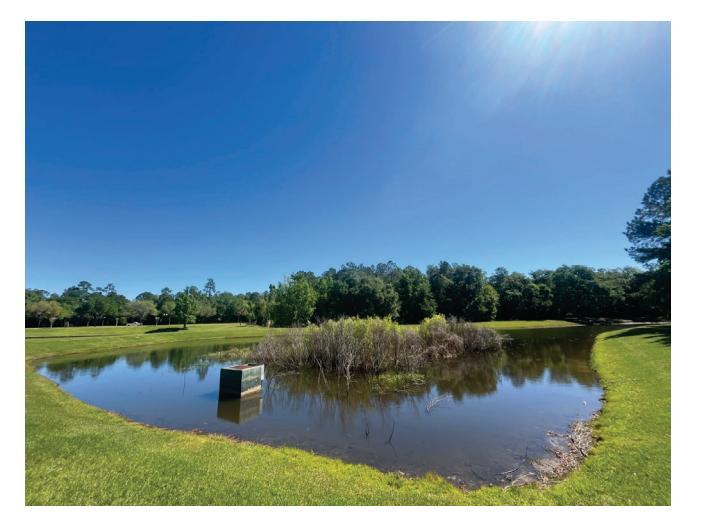
SITE: B2

This pond in near excellent condition. No algae was observed within the pond. Minor amounts of torpedo grass regrowth occuring around parts of the ponds perimeter. Our technician will address in the upcoming treatment.

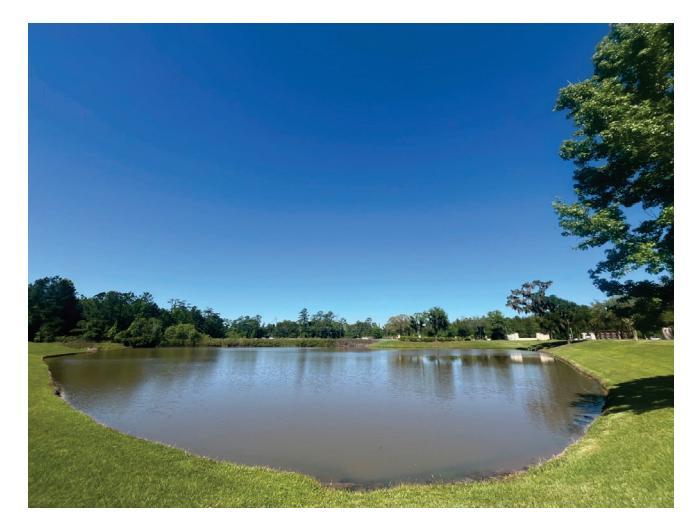
SITE: B3

This pond is also in near excellent condition. Nuisance grasses within the pond's littoral shelf have been treated for and are actively decaying. Around the littoral shelf there is some duckweed that is beginning to form. Our technician is scheduled for treatment next tuesday and will address then.

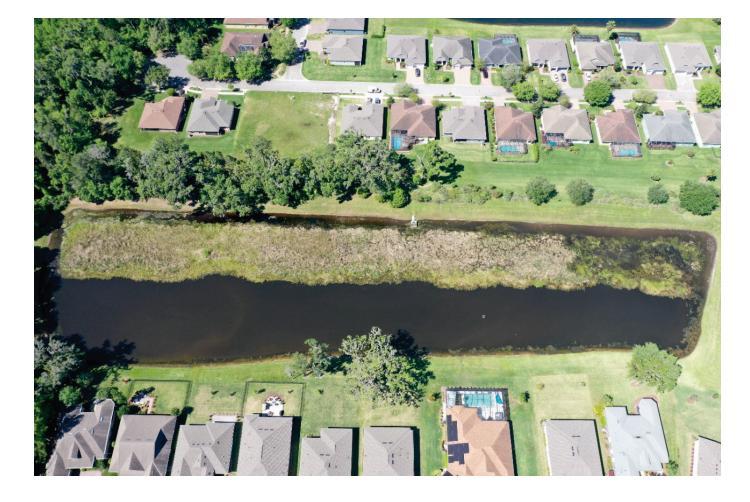
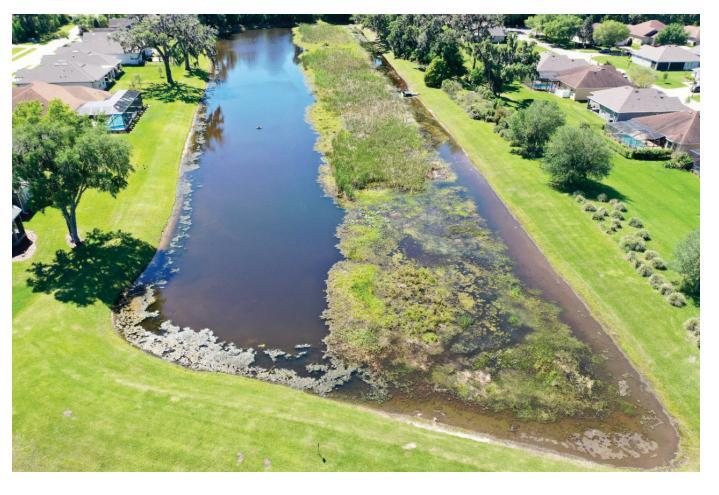
SITE: L-5AA

This pond is experiencing some algae growth that is occurring along the perimeter and around the littoral shelf. During the upcoming visit our technician will target the algae. Typically it will take 7-10 days for the algae to decay and begin to dissipate.

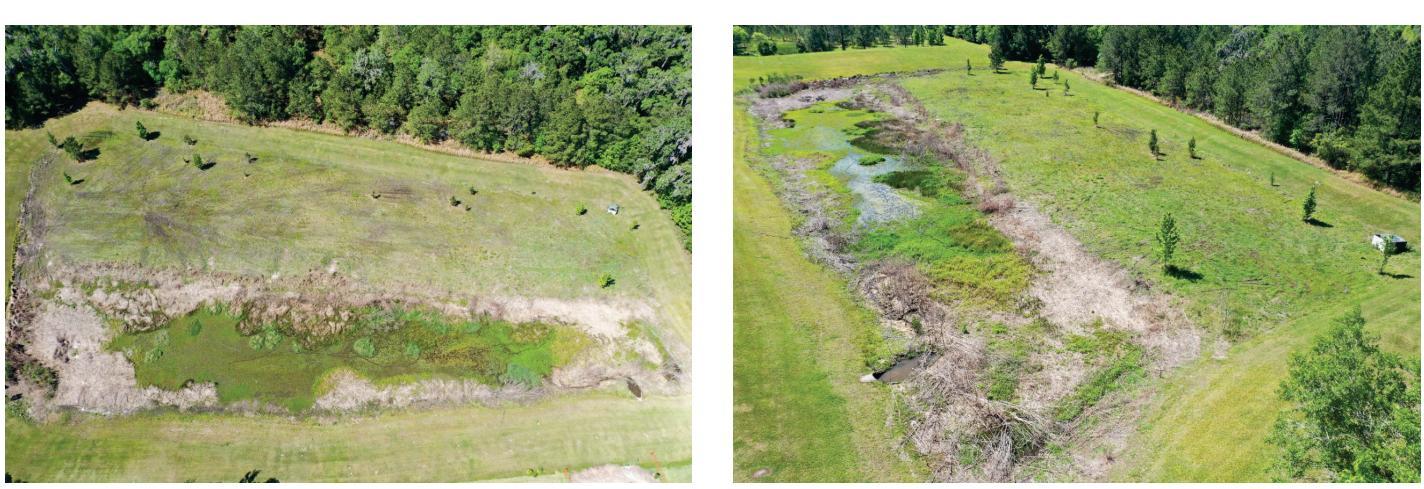
SITE: L-5EE

This pond has very little water located within. Our technician has been targeting nuisance species along the perimeter with the goal of not allowing them to expand and grow too tall. Routine maintenance and monitoring will occur here.

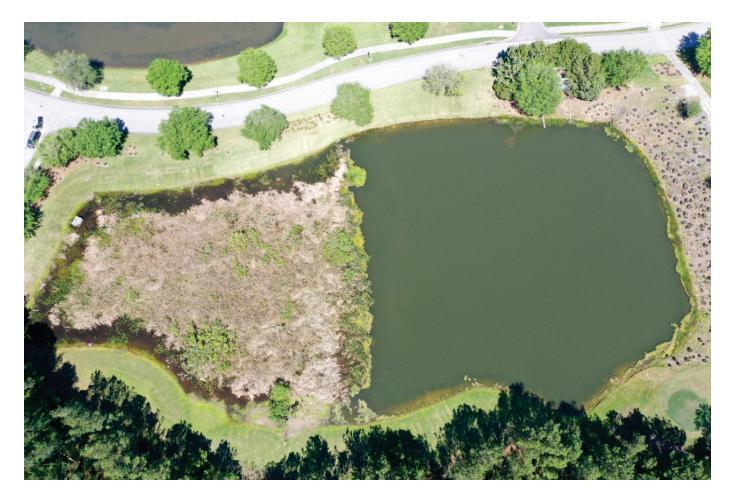
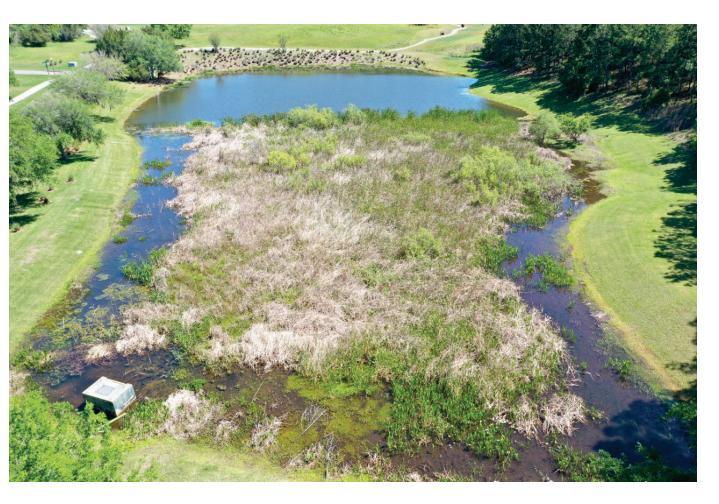
SITE: L-5HH

No algae growth was observed within this pond. There is still a lot of decaying nuisance vegetation around the littoral shelf and along parts of the perimeter. Some progress still needs to be made. Our technician will target any regrowth occurring in the upcoming visit Tuesday.

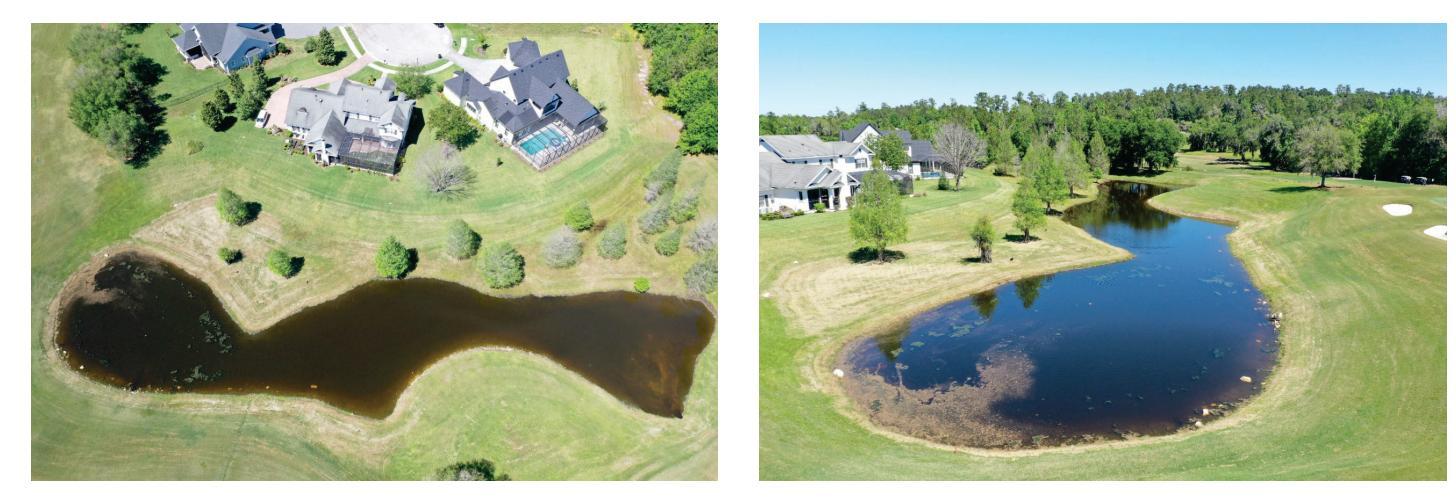
SITE: L-9CC

A lot of the algae that was present within the pond has cleared up from last report. More progress will need to be made. Most of the algae does appear to be decaying from prior treatments. Our technician will make sure to retreat for the algae in the upcoming visit.

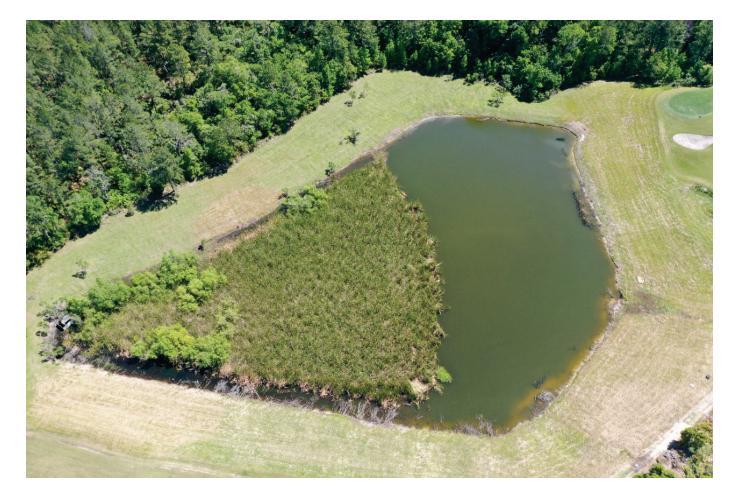
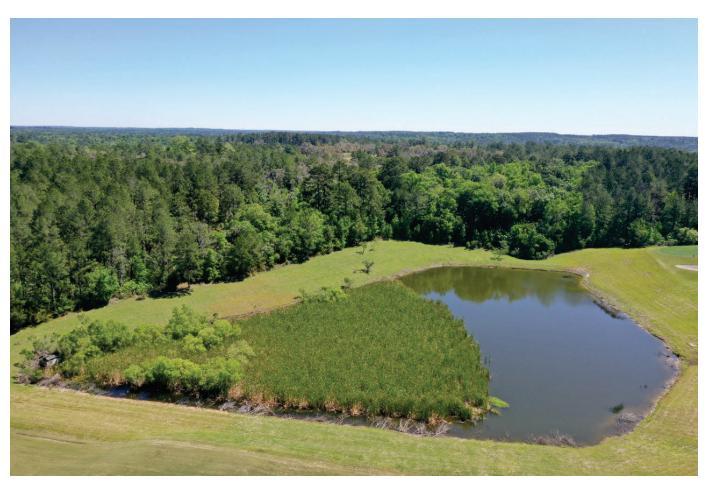
SITE: L-911

This pond is in excellent condition. No algae growth was observed within the pond, same goes for nuisance grasses. Our technician will continue to monitor the status of this pond and will treat for any regrowth that may occur.

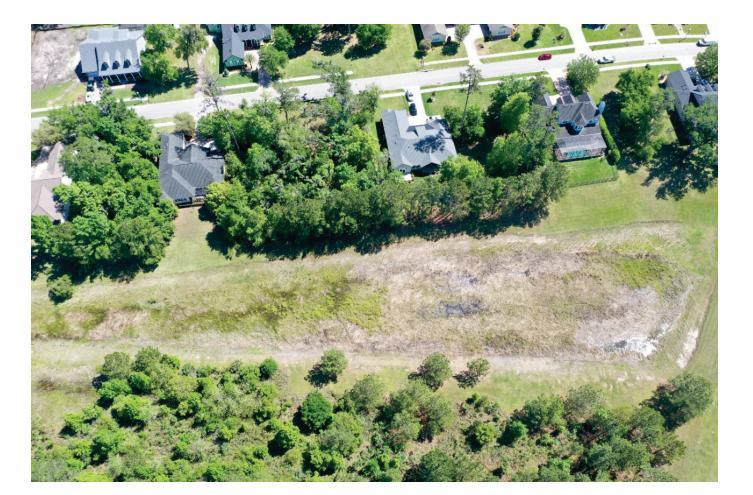
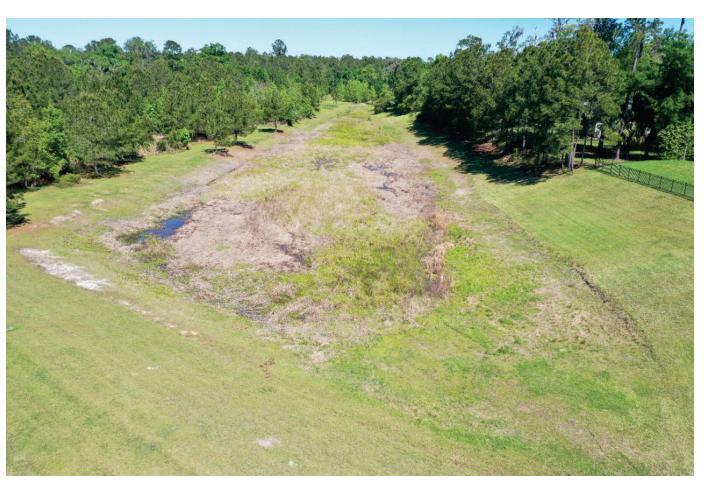
SITE: L-11AA

This pond contains little to no water. Nuisance grasses and species will continue to be treated for with the goal in mind to not allow them to expand past the perimeter. Routine maintenance and monitoring will occur here.

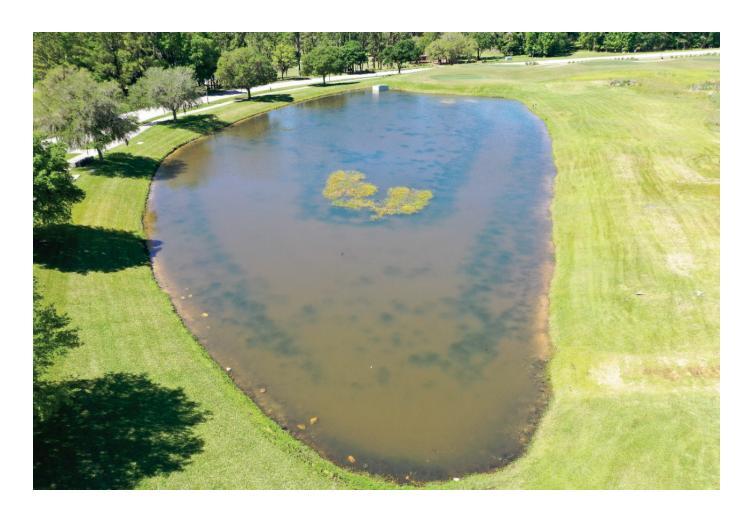
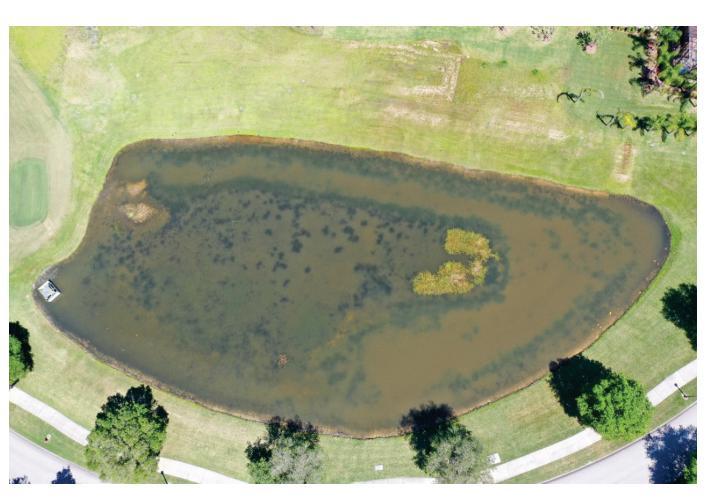
SITE: L-15II

This pond is in excellent condition. No algae or nuisance grasses were observed. Our technician will continue to look for any regrowth and will treat accordingly.
